T-18 Newsletter

January 2004

Van's Wheel Pants on a Thorp

A T-18 GOES FASTER ON LESS FUEL WITH VORTELATORS

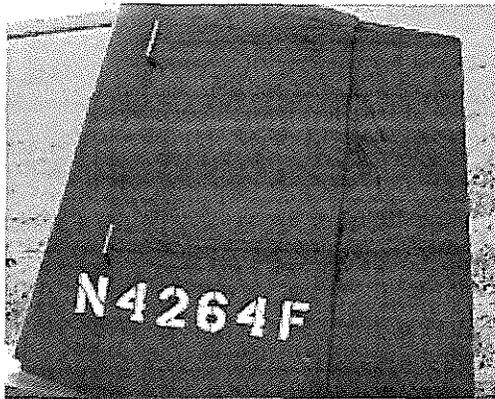
Fig. 7

something interesting about the vertical tail. Figure 7 below is a picture of the left side of the vertical tail. As can be seen from the oil pattern the airflow was uniform from the vortelator until the oil reached the trailing edge of the vertical fin. At which point the oil pattern goes wild, indicating the airflow becomes very turbulent from the trailing edge of the vertical tail aft. Figure 8 below is a picture of the right side of the vertical tail and on this side a vortelator was placed at the widest part of the front end of the rudder. The vortelator did manage to make the airflow more or less uniform and attached to the rudder. I say more or less because the oil streams are less uniform than was seen at other locations on the aircraft. However, compared to the oil pattern on the right side of the rudder there is a vast improvement in the oil pattern and the airflow. Vortelators were placed at similar locations, on the flap, aileron, and anti-servo tab, as they were on the rudder, however, the airflow did not appear to be significantly improved at those locations. I believe the airflow was improved on the vertical fin rudder combination because of the shape of the rudder and that this combination of surfaces are flying at a zero or near zero angle of attack, whereas the other surfaces are flying at a given angle of attack.
