Feb. 5, 1971

T-18 NEWSLETTER NO. 32

L.D. Sunderland, 5 Griffin Dr., Apalachin, N.Y., 13732

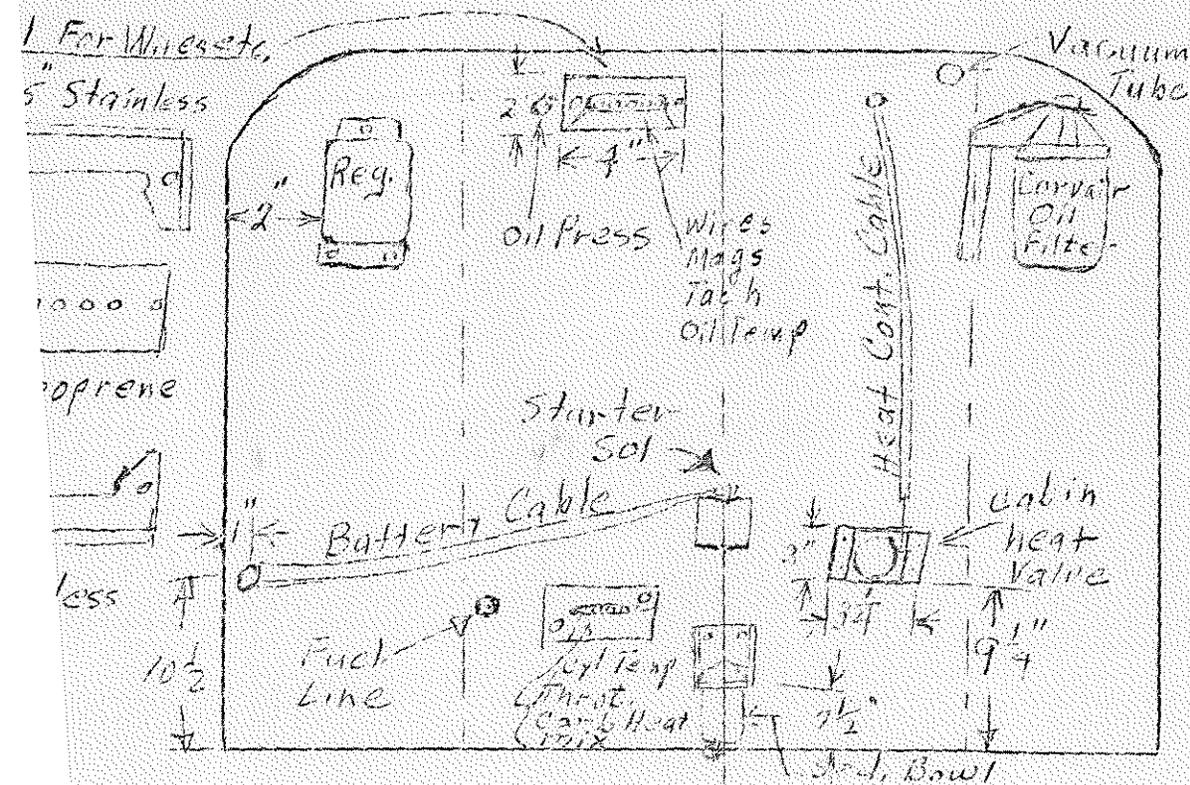
FIREWALL LAYOUT - Ed. - Here is a sketch of my firewall layout which so many have
 questions about. Hope you can figure it out. The homemade bulkhead seal for
 hoses and cables seems to work ok and the FAA didn't object. Sure saves on holes.
