T-18 ACCIDENT ANALYSIS

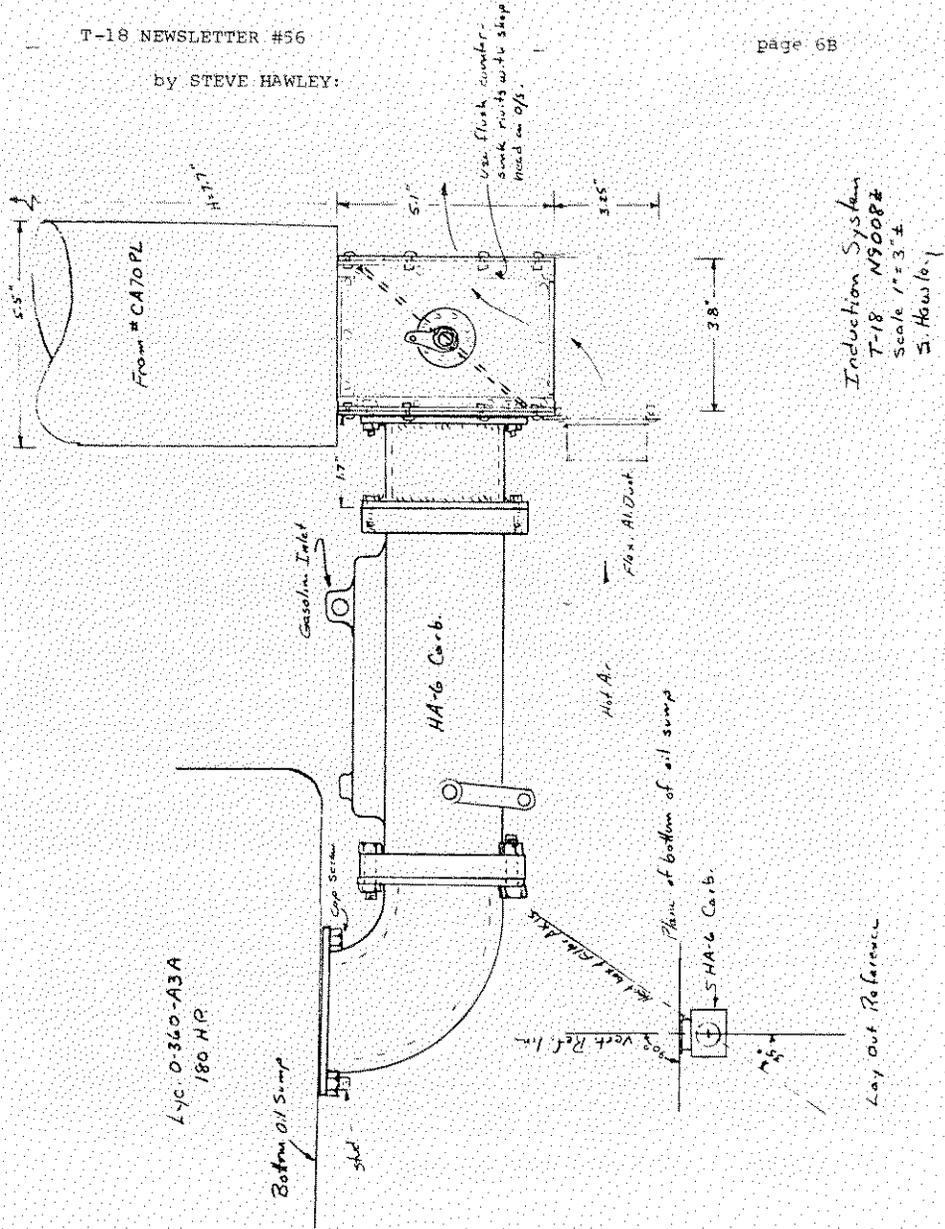
(See drawing of Steve's system on page 6B)

Thanks again, Steve, for the above. We really appreciate it!

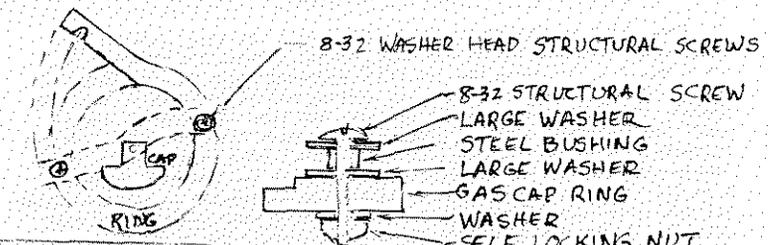
My solution was to install a swinging arm of 0.10" X 5/8" 2024 t-3 supported by 8-32 structural screws tapped into the gas cap outer ring. The arm pivots on one screw and slides under the head of the opposite screw, locking the cap in place. A block attached to the inner face of the gas cap door drops down behind the arm to prevent the arm from swinging open in flight. The block also insures that the swinging arm must be latched before the gas cap door can be closed.

Gas Cap Retention The expanding rubber gas caps most of us use can be blown out by overpressure in a relatively minor impact. Positive mechanical retention is required and the lightweight gas cap doors on most airplanes are not adequate load bearing structures.

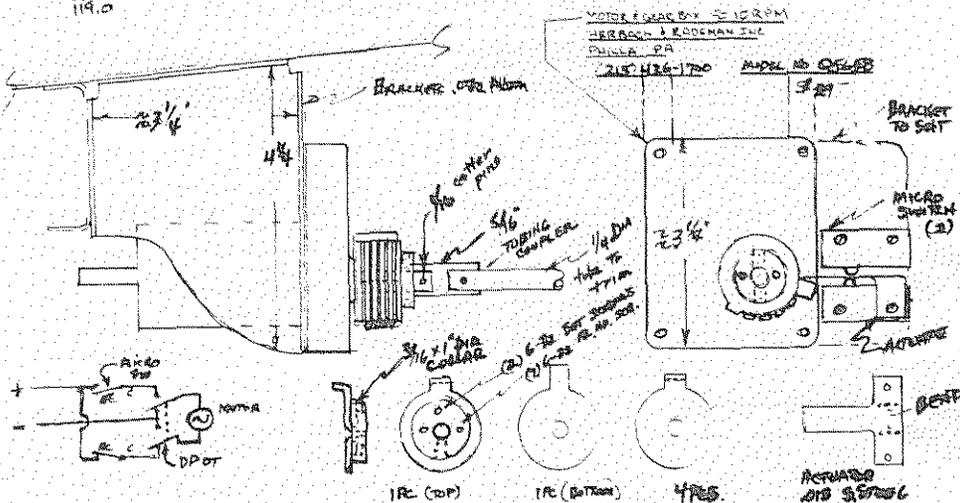
**THE ELECTRIC TRIM** shown in the sketch is ideal. The speed is the same as would be found in a production airplane and the unit only weighs a pound or so. The gear box is about 3 x 3 1/2" and it's approximately 4" long plus shaft. There is plenty of torque to turn the trim. The limit switch system shown was used, so as not to have to run wires and switches down to the tail. I called the warehouse that I bought the motor from and they said they had 13 more in stock and they could re-order more.

DISCS = .050 204T3 TANG IS BENT DOWN AND HITS AGAINST TANG ON DISK BELOW 5.4 TURNS OF SHAFT WILL ACTIVATE SWITCH

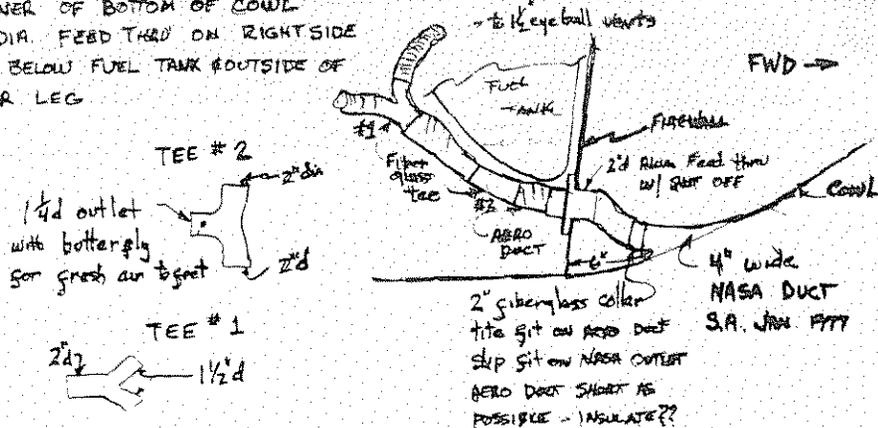
**FRESH AIR DUCT**

4" NASA DUCT IN RIGHT HAND CORNER OF BOTTOM OF COWL  
2" DIA. FEED THRU ON RIGHT SIDE JUST BELOW FUEL TANK & OUTSIDE OF GEAR LEG

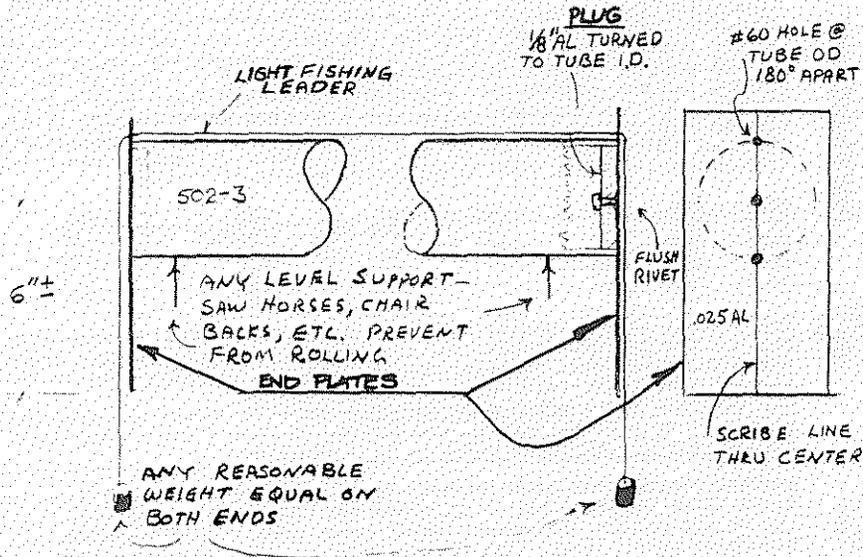
## SCRIBING RIVET LINES ON THE 502-3 TUBE

ROLL TUBE ON A FLAT SURFACE TO DETECT ANY TUBE BEND (MINE HAD ABOUT .032 IN THE CENTER). I ORIENTED MY TUBE FOR POSITIVE DIHEDRAL. TWIST THE END PLATES UNTIL THE FISH LINE MATCHES THE SCRIBE LINE ON BOTH ENDS. SPRAY THE FISH LINE DOWN ON THE TUBE WITH ZINC CHROMATE OR ANY SUITABLE PAINT (DARKER COLORS SHOW UP THE LINE BETTER). SPRAYING FROM THE ENDS WORKING TOWARD THE CENTER WILL PULL THE FISH LINE DOWN IF IT IS HIGH BECAUSE OF TUBE BEND. AFTER THE PAINT SETS PULL OUT THE FISH LINE, ROTATE THE TUBE 180 DEGREES USING THE BOTTOM HOLE TO ALIGN, CHECK PLUMB LINES WITH SCRIBE LINES AND REPEAT THE SPRAY DOWN.

YOU SHOULD NOW HAVE TWO STRAIGHT LINES AS CLOSE TO THE TUBE DIAMETER AS CAN BE OBTAINED WITHOUT VERY EXPENSIVE EQUIPMENT.

FOR AN "I DID IT THIS WAY" I WOULD LIKE TO OFFER MY SOLUTION TO THE PROBLEM OF GETTING TWO STRAIGHT, DIAMETRICALLY OPPOSED RIVET LINES DOWN THE LENGTH OF THE HORIZONTAL TAIL TUBE BEAM (502-3). I CAN'T READ SPIRIT BUBBLES VERY ACCURATELY SO I LET MOTHER NATURE HELP ME IN ANOTHER WAY. THE ATTACHED SKETCH ILLUSTRATES THE PROCEDURE. I'M NOT MUCH OF AN ARTIST SO I HOPE I GOT THE IDEA ACROSS. OTHERS IN THE AREA HAVE USED MY "RIG" AND HAVE FOUND IT EASY TO OBTAIN GOOD RESULTS.
